# TECHNICAL NOTES NATIONAL ADVISORY COMMITTEE FOR AERONAUTICS

No. 736

TIDEWATER AND WEATHER-EXPOSURE TESTS ON METALS

USED IN AIRCRAFT

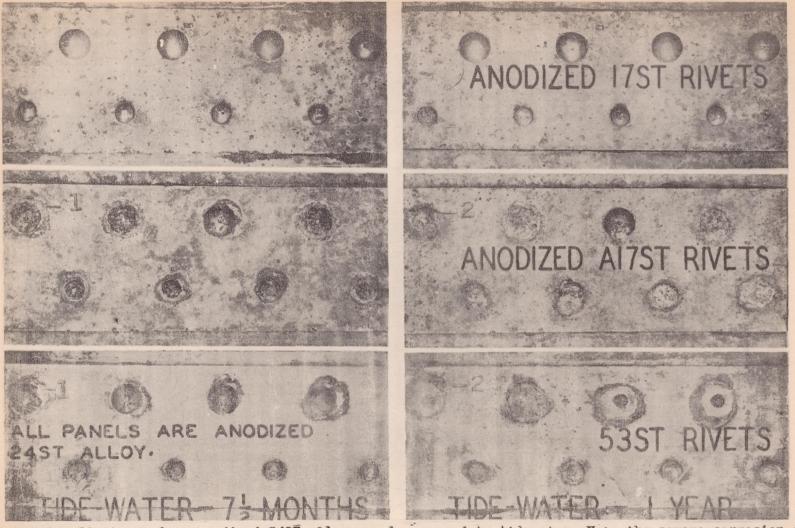
Withdrawals of the riveted aluminum-alloy panels were made after 7-1/2 and 12 months in the tidewater tests and after an exposure of 12 months to the weather. The tidewater tests disclosed that both the anodized A-17ST and the 53ST rivets were anodic with respect to 24ST alloy. Corrosive attack was very severe, especially on the 53ST rivets, from which at the end of a year several heads had corroded completely off (fig. 4). On the other hand, corrosion of the anodized 17ST rivets used with 24ST alloy was only in its initial stage after 1 year's exposure. No attack whatever was observed after a year in tidewater on any of the rivets tested when they were used to join alloys 52S-1/2 H, 53ST, or Alclad 24ST (fig. 5). Hence, the differences in potentials involved for these combinations, in salt water, are either very small or the alloy of which the main panel

Figure 4.- Rivets used on anodized 24ST alloy panels exposed to tidewater. Note the severe corrosion on anodized Al7ST and 53ST rivets, and the relatively slight attack on anodized 17ST rivets. In this, and all of photographs which follow, the large letters at the right apply to the entire horizontal rows, while those at the tops or bottoms apply to the entire vertical rows. × 1

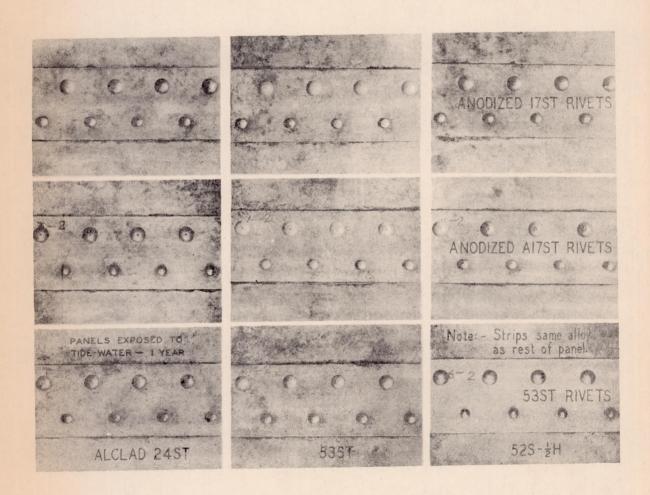
The tidewater tests showed that alloy 52S-1/2 H was the most resistant to attack, with alloys 53ST (sheet or extruded) and Alclad 24ST only slightly less so. Alloy 24ST, anodized or untreated, was noticeably less resistant to attack. Unanodized forged 14ST panels (table I, item 1) corroded in a manner comparable with other duralumin-type alloys.

Figure 5.- Rivets used on panels of Alclad 24ST, 53ST, and 52S-1/2H alloys exposed to tidewater. None of the rivets are corroded. × 1/2

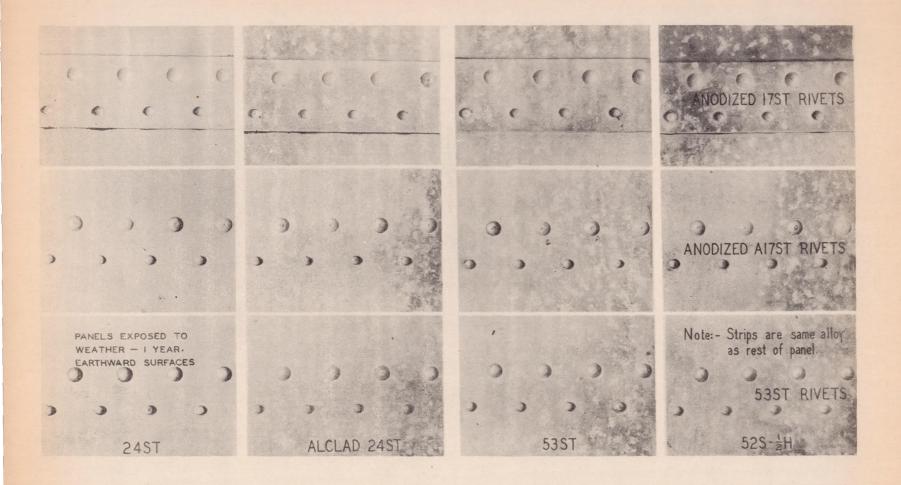
The initial withdrawals of the riveted aluminum-alloy panels in the weather-exposure racks occurred at the end of the first year (fig. 6). There was a marked difference in the behavior of these panels and those from the tidewater tests. No evidence appeared of accelerated attack on the rivet heads that could be attributed to differences in potential. The attack of the anodized A-17ST and the 53ST rivets used to join 24ST alloy was no worse than that of the anodized 17ST rivets. Both the main panels and the rivets possessed small localized areas of corrosive attack, particularly on their earthward surfaces. The anodically treated 24ST panels, however, were practically unattacked, indicating that no failure of the coating had yet occurred.

Figure 6 .- Rivets used on various aluminum-alloy panels exposed to the weather. The rivets on anodized 24ST alloy that were severely attacked in the tidewater tests (fig. 4) show very little attack here. x 1/2

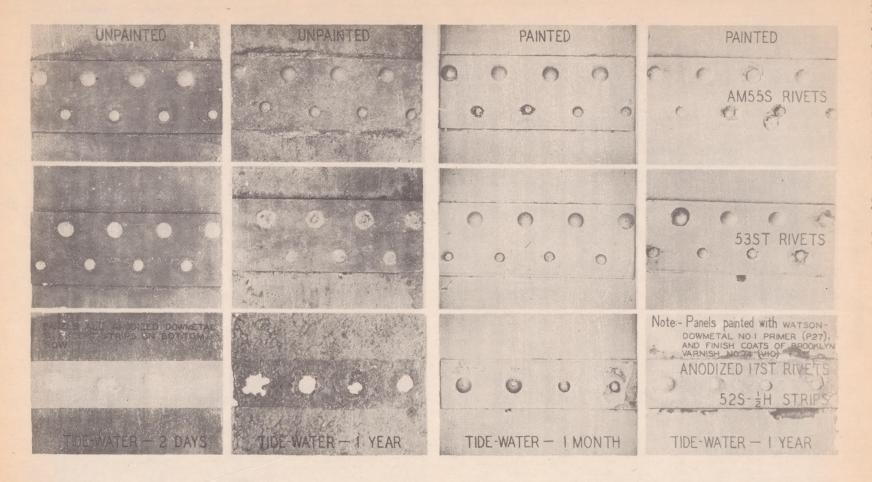
The tidewater tests on unpainted panels conclusively showed that AM55S rivets were the most satisfactory for joining magnesium alloys (fig. 7). The 53ST and anodized 17ST rivets reacted with corrosion products formed from Downetal M, and corrosive attack began during the first day. At the end of 1 year, the heads had all corroded off the 53ST rivets, and the 17ST rivets had completely disintegrated; whereas, the AM55S rivets were still in good condition. Tests on unpainted panels were discontinued at the end of 1 year.

The condition of the painted panels exposed to tide-water is also shown in figure 7. The paint schedule on the type 1 panels (table III, schedule 8) differed slightly from that on the type 3 panels (table III, schedule 10), but both schedules consisted essentially of an aluminum-pigmented V10 varnish applied over a P27 primer. Paint failures began at the rivets after an exposure of about 1 month and, though considerably more advanced, were still practically confined to these areas at the end of 1 year. It is probable that, had the AM55S rivets been anodically treated, paint failures on their heads would have been minimized.

Figure 7.- Rivets on Downetal M panels exposed to tidewater. The AM55S rivets proved far superior to the others and the panels on which they were used were likewise the least attacked. The effectiveness of the paint coatings in preventing attack is noteworthy. x 1/2

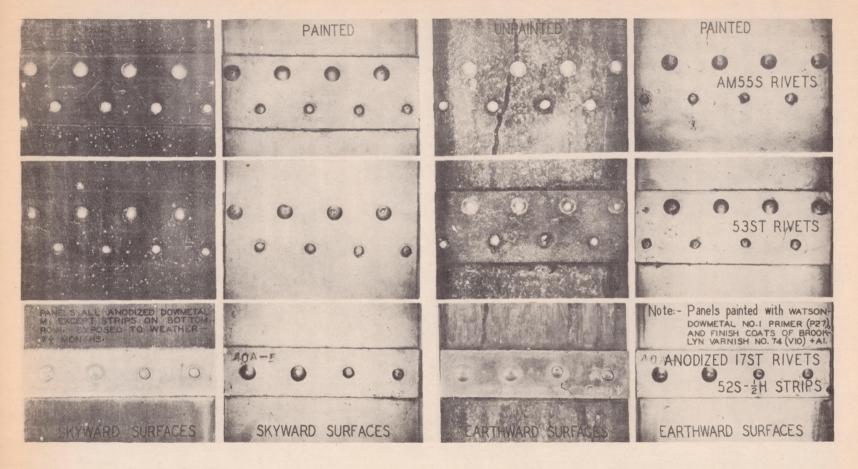
The results of the weather-exposure tests (fig. 8) confirmed those of the tidewater test, but corrosive attack on the rivet heads was very much less severe and the paint failures were much less advanced at the end of 7-1/2 months.

Figure 8 .- Rivets on Downetal M panels exposed to the weather. The AM55S rivets again show the least attack. Corrosion in general was much less severe than in the tidewater tests (fig. 7). ×1/2

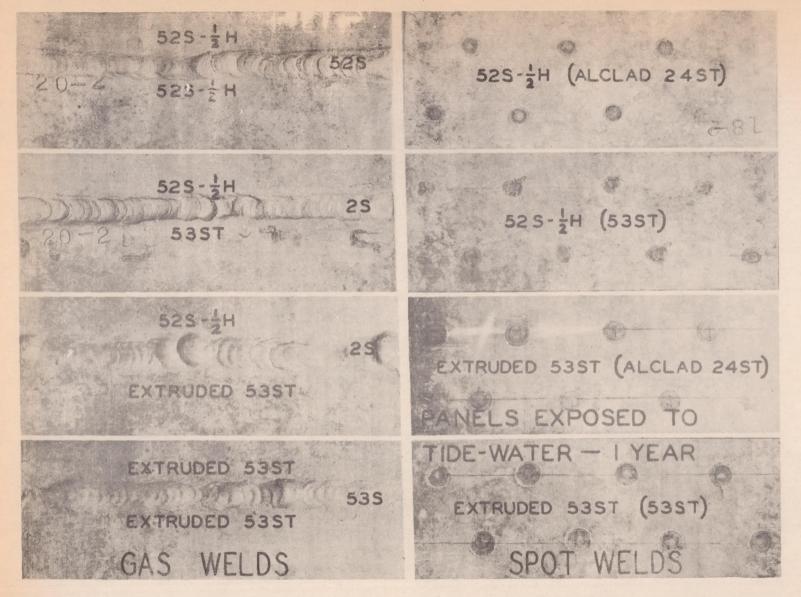
The freedom from corrosive attack on the tidewater panels (fig. 9) indicated the absence of pronounced electrolytic potential effects. Attack on the weather-exposure panels was confined to small, localized areas, principally on unwelded parts of the panel, and mostly on the earthward surfaces.

Spot-welded panels, on which dissimilar aluminum alloys were joined to each other, are also shown in figure 9. The corrosive attack on the welds was relatively very slight and no more than occurred on panels where alloys of the same composition were joined together (figs. 10 and 11). In general, however, the spot welds showed slightly more attack than the gas welds, the greatest amount being present on the 53ST panels and the least on the 52S-1/2H panels.

The seam welds tended to be somewhat less corrosion resistant than the corresponding spot welds. The worst attack, although not severe after a year in tidewater, occurred on the 53ST sheet material (fig. 10). Both spot and seam welds were more corroded in the weather-exposure (fig. 11) than in the tidewater tests.

Figure 9.- Welded aluminum-alloy panels exposed to tidewater. Note the absence of corrosion on the gas welds, and the relatively slight amount present on the spot welds. On the spot welds, the alloy within parentheses was joined to the one pictured. The surface shown is the side on which the greater attack occurred on the welds. × 1

Figure 10.- Welded aluminum-alloy panels exposed to tidewater. The seam welds are somewhat more attacked than the spot welds, the worst corrosion being present on the 53ST sheet alloy. The dark color of some of the welds was caused by the copper electrodes used for welding. x 1

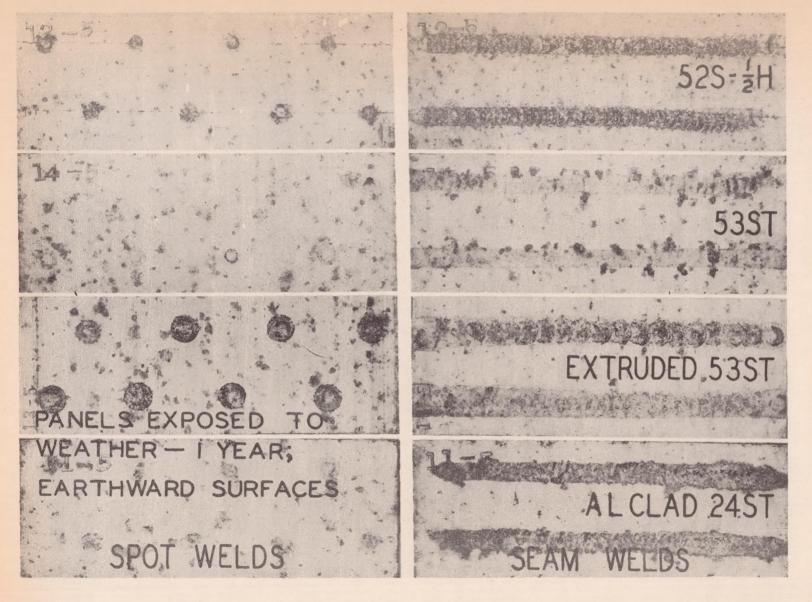
Figure 11. - Welded aluminum-alloy panels exposed to the weather. The attack was more severe, on both types of weld, than in the tidewater tests (fig. 10). × 1

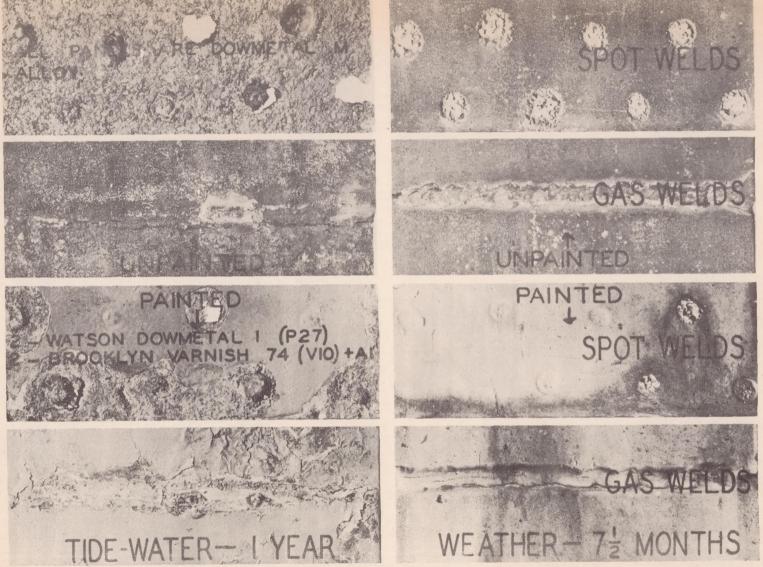
Welded magnesium-alloy panels. The behavior of Dowmetal M alloy, anodized after welding, is illustrated in
figure 12. It will be noted that, at the end of a year in
the tidewater tests, the spot welds were severely attacked,
both on painted and unpainted panels. Corrosion began
within 2 days after installation on the unpainted spot
welds and within a month on the painted spot welds. Corrosion at the unpainted gas welds was no worse than on the
rest of the panel but, on the painted panel, failure occurred at the weld. The superiority of gas-welded over
electric-resistance spot-welded Dowmetal M was also apparent from the weather-exposure test (fig. 12), but the attack
was less severe.

Figure 12 .- Welded Downetal M alloy panels exposed to tidewater or to the weather. The spot welds were very susceptible to attack, but the gas welds were quite resistant. × 1

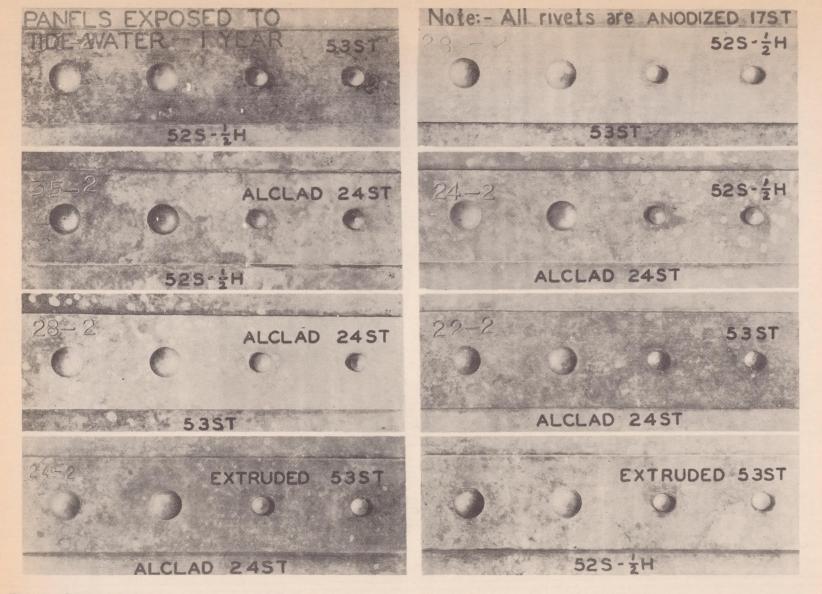
Contacts of aluminum alloys with each other. The tide-water tests revealed that the potential differences were relatively low in various two-member combinations of alloys 52S-1/2H, 53ST, and Alclad 24ST (fig. 13). Each of these alloys, however, was anodic to 24ST and was attacked when in contact with it (fig. 14). Potential differences were highest for the 52S-1/2H and 53ST alloys, and these were very severely attacked when in the form of a 1-inch wide strip fastened to the main panel of the alloy 24ST. With the surface area relationships reversed, however, corrosion was much less severe.

Figure 13.- Panels exposed to tidewater and having various aluminum alloys in contact with each other.

Note the absence of corrosion products around the edges of the strips, except for a slight amount on the 52S-1/2H panels with the Alclad 24ST strip. ×1

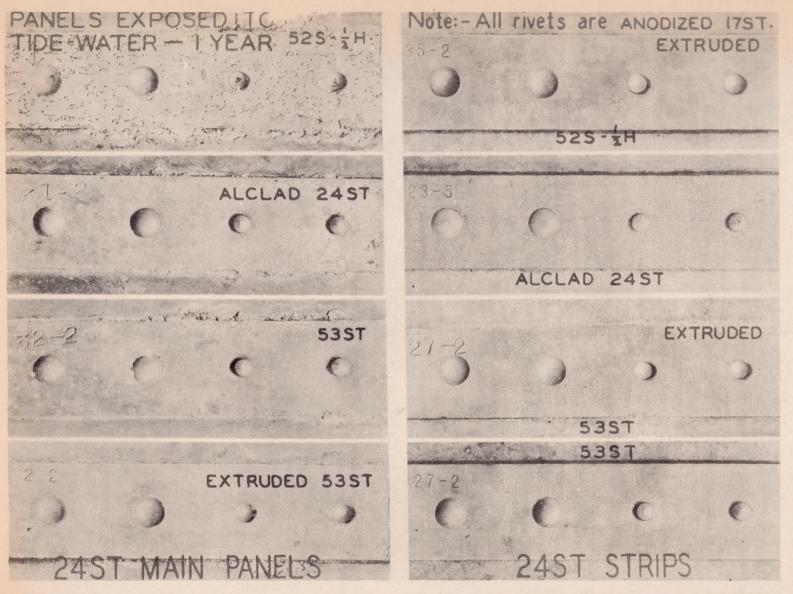
Figure 14.- Panels exposed to tidewater and having 24ST material in contact with other aluminum alloys, which were anodic to it. Note the very severe pitting on the 52S-1/2H strip and the differences in behavior depending on which alloy had the greater area. x I

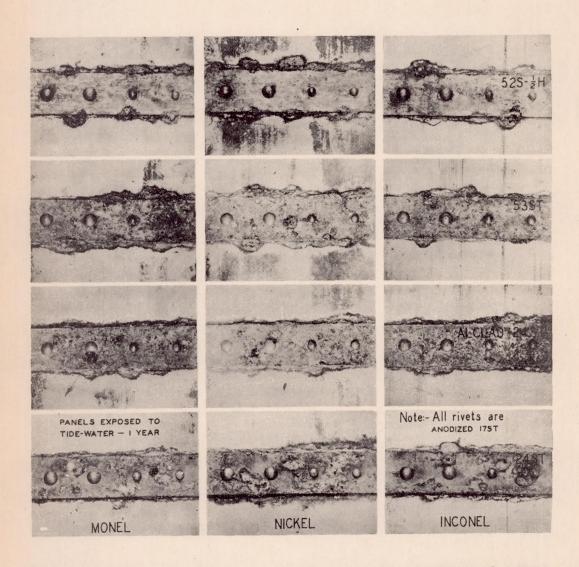
Contacts of aluminum alloys with nickel alloys. The aluminum alloys were used as the l-inch-wide contacting strip on a series of main panels consisting of nickel, monel metal, and Inconel. The tidewater and the weather-exposure tests revealed that the aluminum alloys were anodic toward these nickel alloys and were severely attacked when in contact with them (fig. 17). The potential differences involved were apparently of the same magnitude as those between the aluminum alloys and the stainless steel and indicate the advisability of insulating such contacts in practice.

Figure 17.- Panels exposed to tidewater and having aluminum-alloy strips in contact with various nickel alloys. The aluminum alloys were anodic and were severely attacked. × 1/2

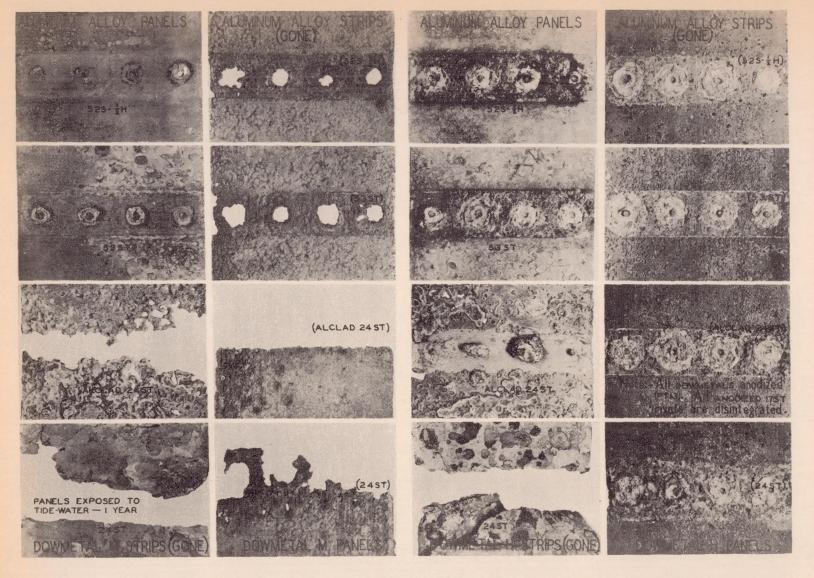
Potential differences were highest between the magnesium alloys and the 24ST and the Alclad 24ST alloys and lowest with magnesium alloys and the 53ST and the 52S-1/2H alloys. The 53ST and the 52S-1/2H alloys are to be preferred when the use of aluminum in contact with magnesium alloys is necessary. Under severe corrosive conditions, however, the coupling of these materials is inadvisable. Tests on the unpainted panels were discontinued at the end of the first year, owing to the severity of the attack (fig. 18).

The insulation afforded by the paint coatings was insufficient to prevent fairly rapid attack in the tidewater tests. On the painted panels, paint failure on the aluminum alloy strips was practically complete at the third month, and the attack thereon was severe at the end of a year (fig. 19).

In the weather-exposure tests, on unpainted panels, the l-inch-wide contacting strips of Downetal M on 24ST, Alclad 24ST, and 53ST alloys were completely disintegrated at the end of 6 months; similar strips were fairly severely attacked when joined to alloy 52S-1/2H. Under the same conditions, however, Downetal H strips were very much less attacked and were in no case disintegrated. When the Downetal alloys constituted the main panels and the aluminum alloys the strips, severe corrosion at the faying surfaces occurred only with the Alclad 24ST and 24ST combinations. On the painted panels, failures were relatively small after

a year's exposure, being greatest on the Alclad 24ST and 24ST strips (fig. 19). Hence, with adequate insulation at the faying surfaces, provided that corrosive conditions are not too severe, these alloys could probably be used together successfully.

Figure 18.- Unpainted panels exposed to tidewater and having aluminum and magnesium alloys in contact. The potential differences were high and the alloys initially constituting the strips practically all disintegrated. The aluminum alloys were cathodic but were in turn attacked by the corrosion product resulting from attack of the magnesium alloys. × 1/2

Figure 19.- Painted panels exposed to tidewater or the weather and having aluminum and magnesium alloys joined together. The insulating effect of the paint appreciably retarded corrosion, especially in the weather-exposure tests. Potential differences were highest between the magnesium alloys and the 24ST and Alclad 24ST aluminum alloys. × 1/2

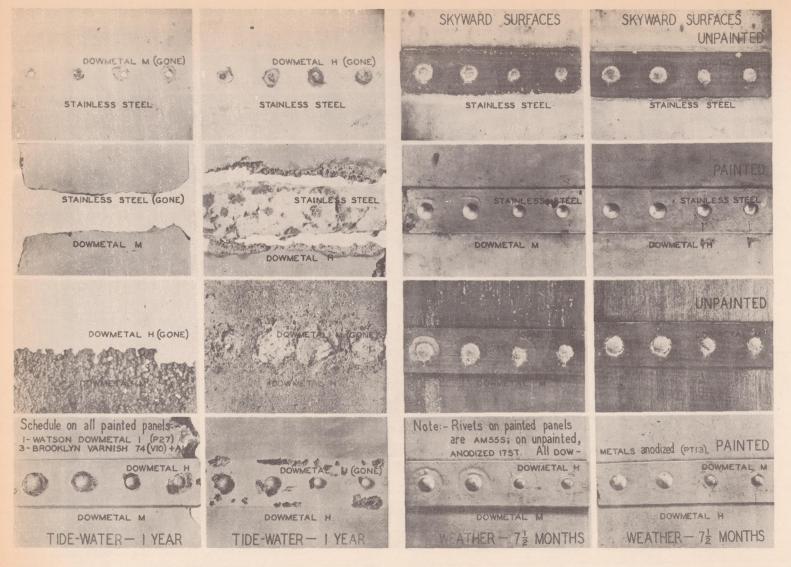
Contacts of magnesium alloys with each other. The results of the action of Downetals M and H, when in contact with each other, are shown in figure 20. The tidewater tests revealed that Downetal M was anodic to Downetal H, and strips of the former disintegrated entirely, even on painted panels. In the weather-exposure tests, however, the attack was not severe, even on unpainted panels. Under relatively mild corrosive conditions, therefore, these couplings should give satisfactory service when given a protective paint coating.

Contacts of magnesium alloys with stainless steels .-The coupling of magnesium alloys with stainless steel (table V, item 2) proved the worst of all the dissimilar metal contacts tested, as the magnesium alloys were very severely attacked (fig. 20). Immediately after the first tidewater had covered the panels, violent bubbling of the water occurred, and the reaction was audible for a distance of approximately 15 feet. The Downetal M was attacked somewhat more rapidly than the Downetal H. An adherent white corrosion product was deposited on the steel; the deposit was 0.004 inch thick at the end of 2 days. The white deposit gradually became removed and the underlying steel was unattacked. When the main panels consisted of Downetals, they were attacked so severely around the edges of the stainless steel strips that most of the latter ultimately fell off. The appearance of panels at the end of a year in tidewater tests, and of 7-1/2 months in weather-exposure tests, is shown in figure 20. The attack was much less severe on the weather-exposure than on the tidewater panels, and failures on the painted panel,s were not very far advanced after 7-1/2 months.

Figure 20.— Panels exposed to tidewater or the weather and having magnesium alloys in contact with each other or with stainless steel. The potential differences involved were higher than for any other contacts investigated, and the magnesium alloys were very rapidly attacked when next to stainless steel. Downetal M proved ancide to Downetal H. Painting afforded considerable protection, especially in the weather-exposure tests. × 1/2

Figure 21.- Anodically treated 24ST panels exposed to tidewater or the weather with various protective paint coatings. Although the coatings all afforded excellent protection under the severe conditions, failure has begun, in the tidewater tests, on the Ll2a lacquer and on the 52Vl5 varnish on a P23 primer.  $\times 1/2$

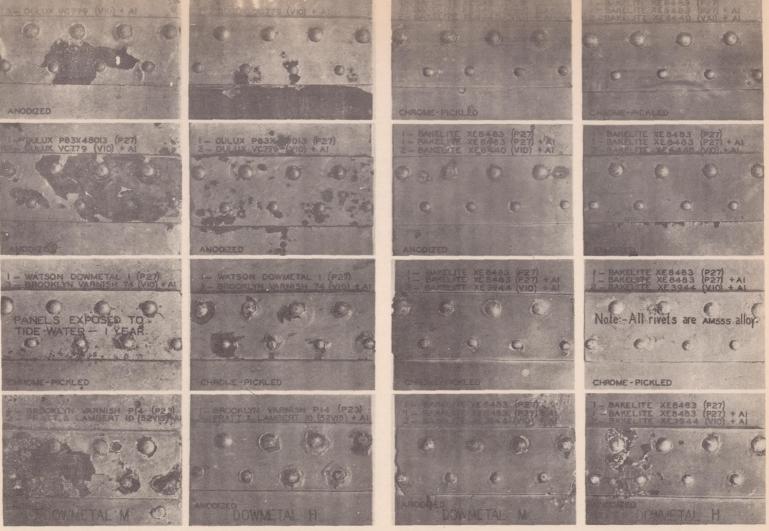
The surface appearance of panels initially included in the program and exposed for 1 year to tidewater (fig. 22) indicated the possibility of using the alloys under relatively severely corrosive conditions, provided that the best available surface treatments and protective paint coatings are utilized.

It will be noted (fig. 22) that, except for failure around the rivet heads, two of the paint schedules afforded relatively excellent protection after a year's exposure in tidewater (table III, schedules 10 and 12). This result attests to the considerable progress made in the development of methods for the protection of magnesium alloys; only a few years ago it would have been considered impossible to protect these materials for as long a time under such severely corrosive conditions. It is noteworthy also that, while five of the paint schedules included finish coats of aluminum-pigmented varnishes that conformed to Navy Specification V10, two of these proved much superior to the others. It follows that conformity to this specification is not necessarily an assurance of the highest merit attainable in a varnish.

Figure 22.- Magnesium-alloy panels exposed to tidewater with various protective paint coatings.

The schedules having the Bakelite XE3944 or the Brooklyn 74 vernishes over a P-27 primer afforded excellent protection. Note the difference in behavior of various coatings conforming to Navy Specification VIO. The chrome-pickle surface treatment proved somewhat more effective than the anodic treatment on the Dowmetal H panels. × 1/2

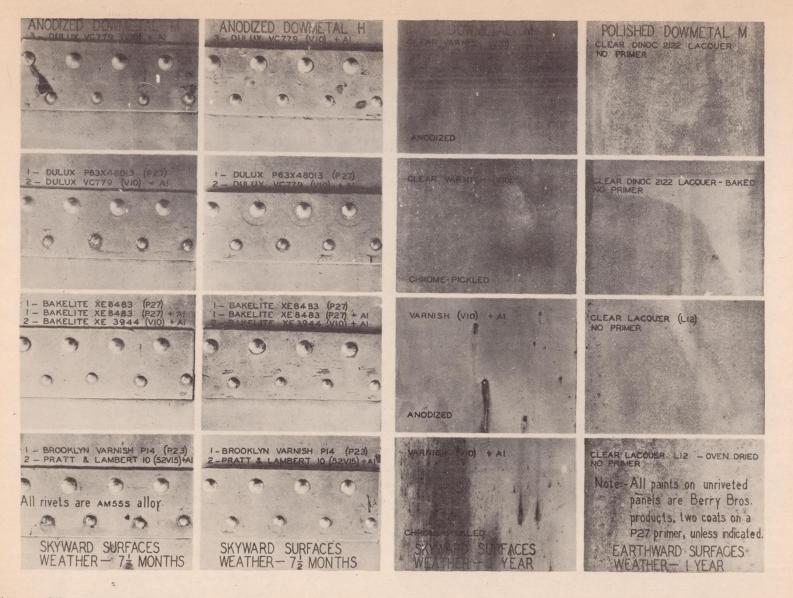
In the weather-exposure tests (fig. 23), after a year, paint failures were confined to the AM55S rivet heads, except on two of the inferior schedules (table III, schedules 5 and 6), irrespective of the method of surface treatment.

The tests again emphasized the need for careful selection of paint schedules. For example, the use of unpigmented lacquers or varnishes applied to untreated surfaces (fig. 23) resulted in more or less uniform corrosion of the metal. Baking treatments afforded little, if any, improvement in protection. Although the corrosive attack was somewhat less when surface treatments were also utilized, the inferiority of the unpigmented paint coatings was evident. The orange-yellow and the Navy gray pigments in the L12 and L12a lacquers and in the E4D and E5D enamels (fig. 24) also proved unsatisfactory. These coatings were badly cracked and chalked at the end of the year. The aluminum-pigmented vehicles afforded the best protection, but failures were quite numerous on these.

Figure 23. - Magnesium-alloy panels exposed to the weather with various protective paint coatings.

Note the inferiority of the unpigmented paints, especially those applied to polished surfaces, as evidenced by numerous pin-point areas of corresion product formed beneath the coatings. x 1/2

Figure 24.- Magnesium-alloy panels exposed to the weather with various protective paint coatings applied over chrome-pickled or anodized surfaces. Failures occurred on all these panels. The Navy gray coatings chalked badly. The anodic treatment proved somewhat superior to the chrome-pickle treatment, but not enough so to be of much practical significance. × ½

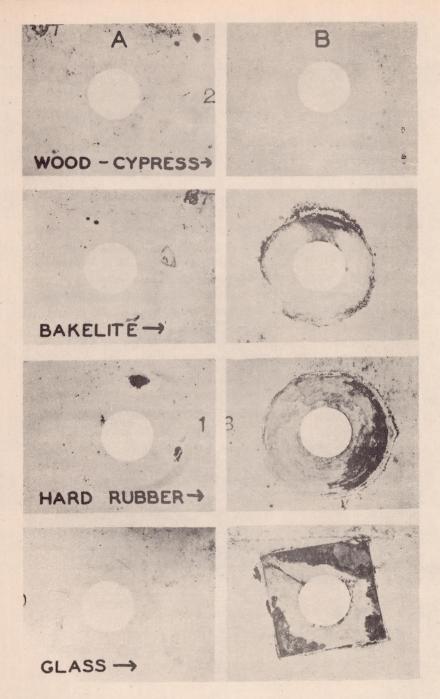
The tests have shown that any of the materials used are suitable for suspending stainless steel in tidewater tests, provided that the four-point method is used. Where the areas of contact were relatively large and no provision was made for drainage, "inert" materials such as wood, glass, hard rubber, and bakelite were relatively unsatisfactory (fig. 25), even though springs kept the suspending mediums in very close contact with the steel. Painting of wood and bakelite separators tended, if anything, to increase the severity of the attack. Monel metal, brass, or copper separators proved satisfactory irrespective of the method of suspension, or whether a complete electric circuit was possible. Owing to the possibility that they may influence the rate of attack on the panel, because of potential differences and the existence of electric circuits, it is deemed unwise to use dissimilar metals for supports in tidewater tests.

Figure 25.- Relative efficiencies of various materials used as separetors (fig. 3) for suspending stainless-steel panels in the tidewater tests. Column A panels were suspended by the four-point method; Column B panels were in contact with the supporting medium over an area approximating 1 square inch. All panels shown were exposed for 1 year. Note the superiority of the point method of suspension. x 1

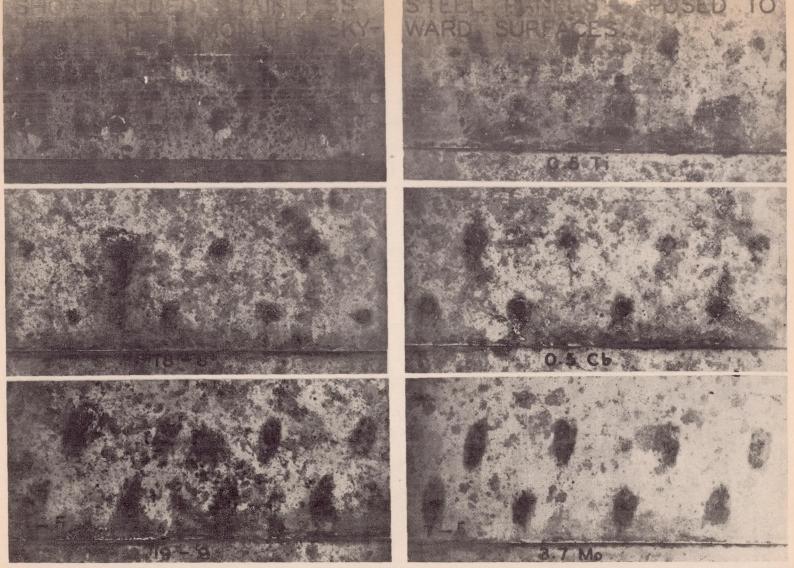
Corrosion was much more noticeable on the stainlesssteel panels exposed to the weather than on those in the
tidewater tests. Panels exposed to the weather became
covered more or less uniformly with thin, but adherent,
rust films (fig. 26). The rust formed during the first
month and gradually became slightly thicker during the
year. Accumulation of dust and soot may have been partly
responsible for the corrosion.

The quantity of rust present on the 16-1 chromiumnickel alloy was greater than on the others. The straight 18-8 and 19-9 types and the 18-8 type containing columbium or titanium all behaved approximately alike, and the rust film thereon was quite thick after a year. The amount of rust on the molybdenum-containing steel was very much less than on the others, and it was clearly the most corrosion resistant (fig. 26).

Figure 26.- Stainless-steel panels of various compositions, exposed to the weather. Note the prevalence of rust that formed in thin, but adherent layers and tended to be worse on the welds than on the rest of the panels. The steel containing molybdenum proved appreciably more corrosion resistant than the others. ×1

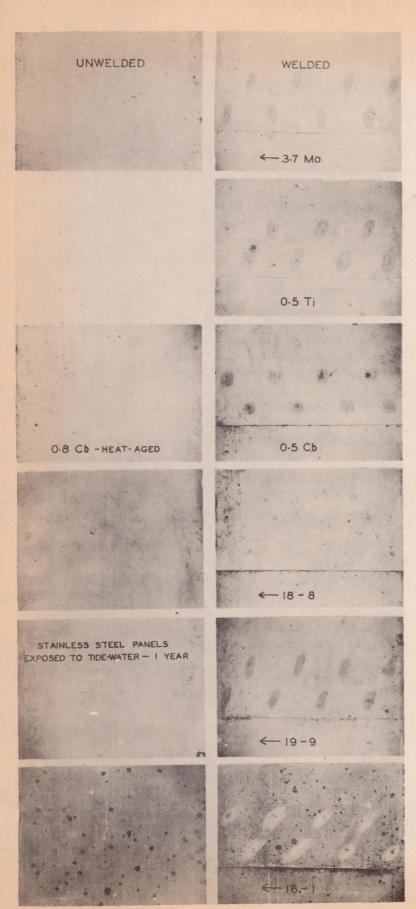
panels exposed to tidewater for one year. The attack was much less severe than in the weather-exposure tests (fig. 26), but the 16-1 chromium-nickel alloy again proved the most susceptible to attack. × 1/2
